# Satellite-Based Subsurface Soil Moisture Mapping: Rail Monitoring in France

The project in question concerns the concessionaire of a high-speed rail-line in Southwestern France.

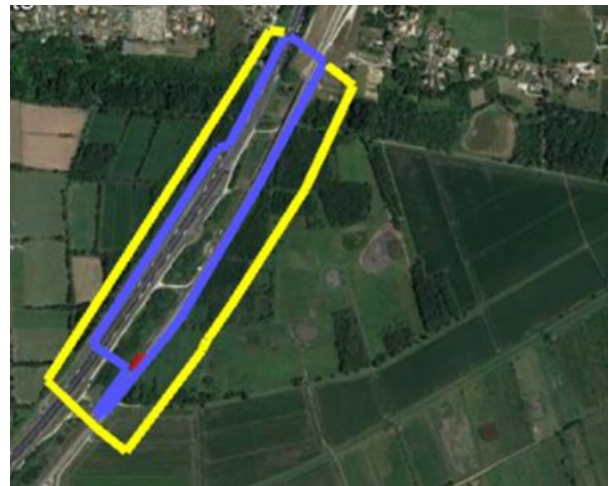
**Area of Interest:** The blue line shows the area of subsidence provided by the concessionaire. The yellow line is the area analyzed by ASTERRA.

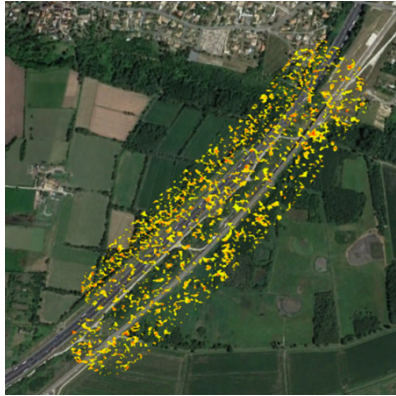
**Soil moisture map of the area within the yellow polygon based on the 2017 image.**

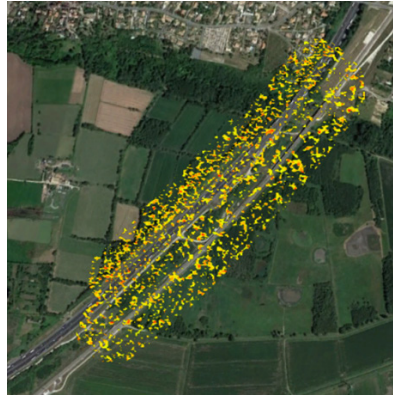
**Soil moisture map of the area within the yellow polygon based on recently acquired image.**

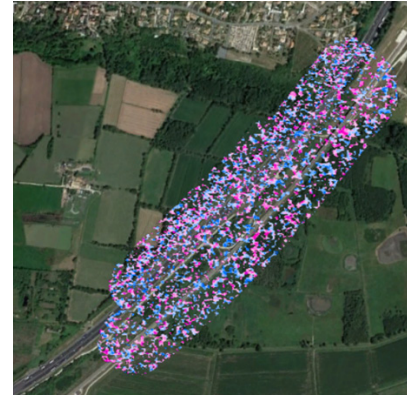
**Spatial and temporal change/difference highlighted, highlight, between 2017 image and the recent satellite image.**

ASTERRA's data helped confirm the following hypothesis: The problem is likely probably associated with the embankment construction materials, not the foundation. If the problem originated from a break in the foundation, the observed movement would have been more severe, which is not the case.

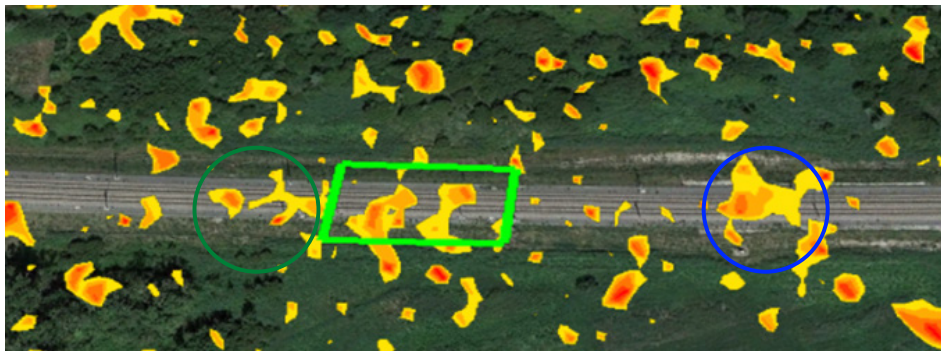
In 2019, in the marked green area, movements were detected that correlates well with ASTERRA's soil moisture data. In the blue circle, the concessionaire believes the results to be of note because they have not noticed any sign of movement there yet. A visual and localized inspection in the field is thus required to check the embankment and track bed.
