Remote imaging reaches beyond antiquities

A satellite-directed leak identification technology developed by Utilis has been deployed in more than 20 projects in Italy in a partnership with 2F Water Venture, a leak detection company based in Padova. **Paul Gagliardo**, Senior Technical Fellow of Utilis explains how the technology works and how utilities can employ it to reduce water loss through leakage.

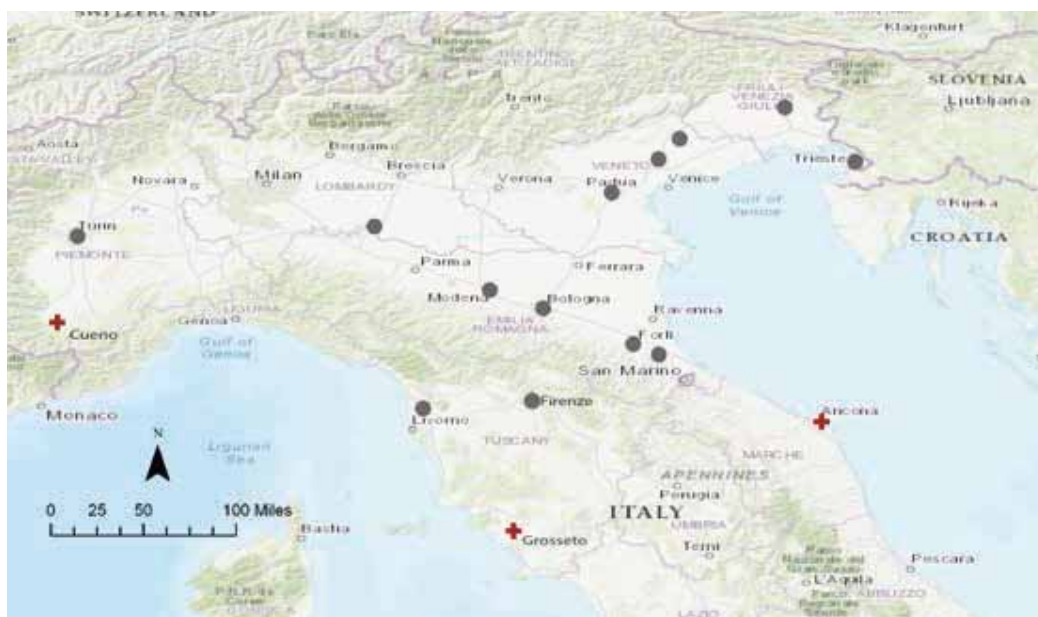
Figure 1. Locations of 2F Water Venture projects carried out in the past 2 years are shown in the above figure. Cities marked with red crosses are discussed in this article.

based technology company Utilis and 2F Water Venture, which has already established a successful and proven record in Italy with more than 20 completed leak detection projects (Figure 1), is likely to benefit from the government's new focus on water efficiency. Based in Padova, 2F Water Venture distributes innovative products for the integrated water utility service market focusing on leak detection in potable water mains, and the company is a part of Integrated Watercare Solutions (IWS) Group. 2F Water Venture signed an exclusive agreement with Utilis in December 2016 to resell satellite leak detection services in Italy.

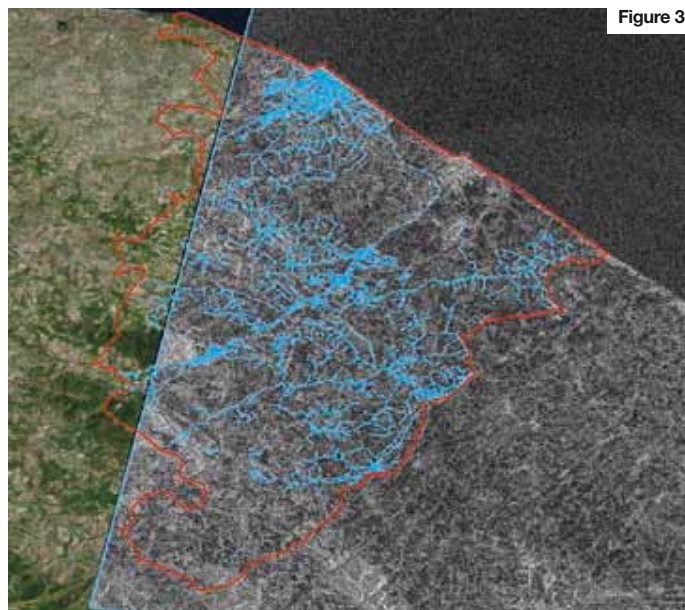
Figure 3

Utilis-supplied data of pipeline routes are used in conjunction with the satellite imagery (Figure 3) to indicate points of interest (POIs) that are likely leak locations (Figure 4). Images supplied by 2F Water Venture

In leak detection projects deploying the Utilis methodology, the process starts when 2F Water Venture and its water management customer identify the area of interest (AOI) to be analyzed by the satellite image. The satellite travels over the same location on earth every 14 days. The image collected covers a terrestrial area of 56 kilometers (km) by 72 km. Within this AOI lies the system of water pipelines to be surveyed. The satellite image is received and analyzed in conjunction with the utility-supplied data of pipeline routes to identify likely leak locations (Figure 3). The output deliverable is a GIS-based map showing points of interest (POIs), also considered likely leak locations (Figure 4).
