Leak Detection In Water Supply Network Using Satellite Technology

Pančevo, Kovin, Kovačica

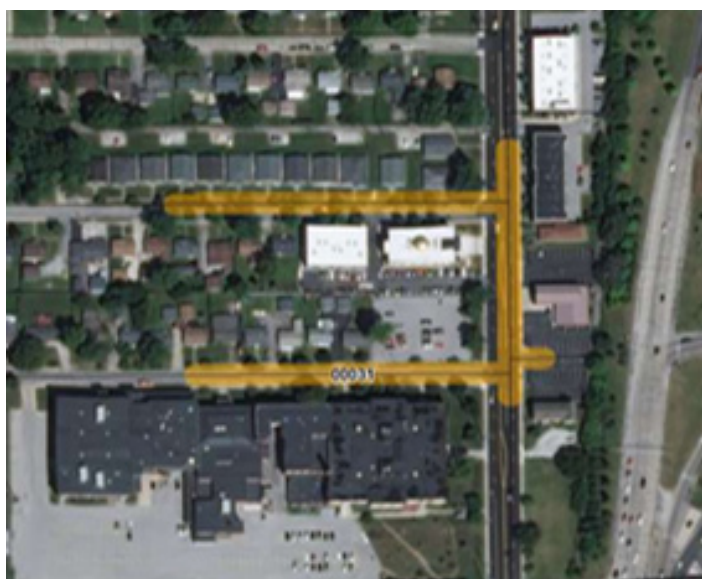
so-called spectral "signature", which symbolizes all the peculiarities and differences, characteristic of the required drinking water and which, more precisely, represents the relationship between the electromagnetic wavelength and its interaction with water. The peculiarity of this drinking water (dielectric constant) is that it produces high dielectric constant in the soil, unlike other types of water (salt water, polluted water, lake water, etc.), and such a signal is returned to the radar sensor where the triage of all types of water was performed, with the help of a special algorithm, and only that recognizable, arrived "signature" of the requested drinking water was retained. Thus, powerful radar devices will provide locations of leaked drinking water, in the form of "spots", on the surface of the recorded space, which, after overlapping with GIS maps, will provide approximate street locations (Figure 1), or points of interest (POI) where with field acoustic devices, the detected exact leaks are marked in green, then suspicious places are marked in yellow, silent signals are marked in red and finally, in the unverifiable state, they are marked in blue.

Figure 1. Points of Interest (POI) up to 100 m in diameter

In terms of the previous, it is extremely important to mention that the color on the satellite image does not show the size of the leak, but how strongly the "signature" of the required drinking water is registered, in contact with the ground, which again indicates only the probability of its existence. An example is the researcher's experience, "that a large leak that lasts, say, a few days, can give the same "signature" as a very small leak that lasts several years" (!).

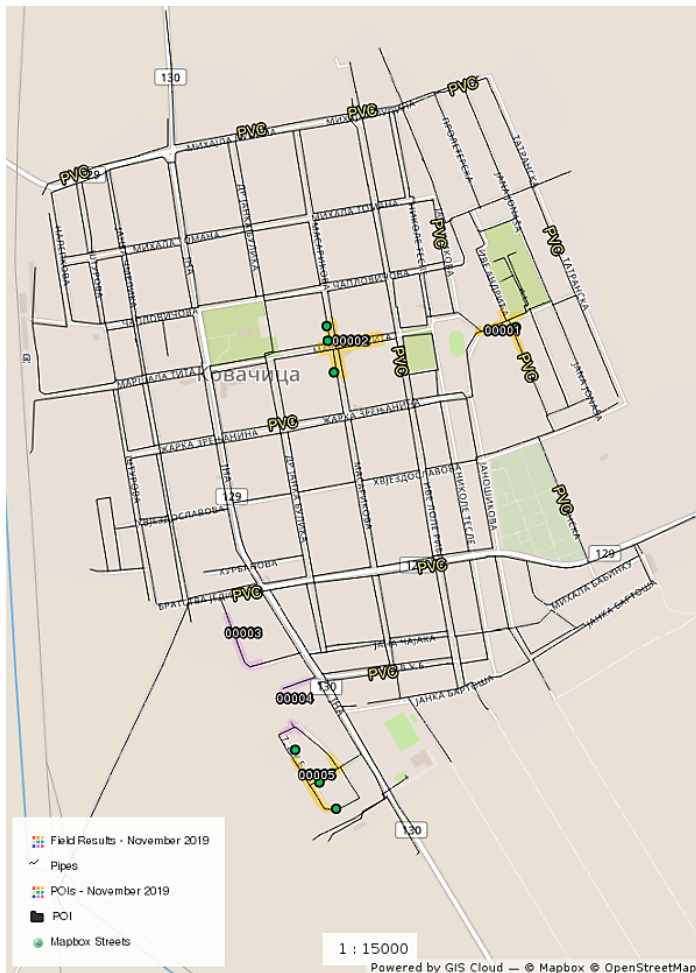
The settlement of Kovačica (Figure 7) was also covered by satellite imaging and in that area 8 leaks were detected

at the connections (6 to the water meter and 2 behind the water meter), and 1 unverifiable, on the 62 km long network, with 2360 connections, as this is shown in Table 3, Table 4 and Table 5.

Figure 7. Water supply network of Kovačica settlement with locations of detected (and potential) leakage

If the level of maintenance of the distribution system in the settlement of Kovačica was checked, then according to the known standards (Table 6), a conclusion would be made about the high level, with the recommendation to "maintain this level".
