# Using Satellite RADAR Imaging to Detect Pipeline Leaks in Texas – New Braunfels Utilities Case Study

By Paul Gagliardo, Independent Consultant, Encinitas, California

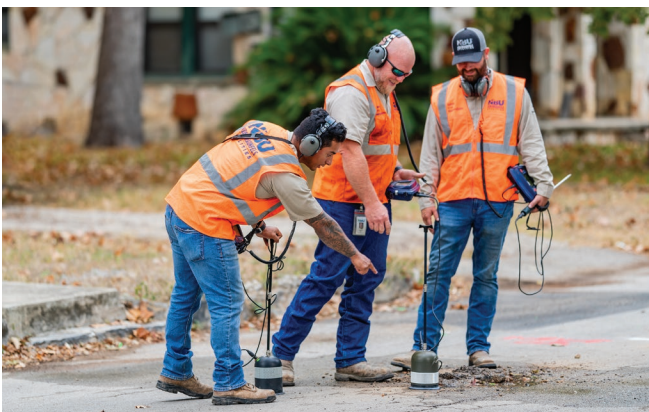
NBU staff investigating an LLL from Utilis

NBU crews spent 56 working days performing physical inspections of the LLLs, searching for the origins of the leak signals. A total of 229 leaks were located and pinpointed.
