Recovering Lost Water

Innovative leak detection technology provides value to small rural water utility

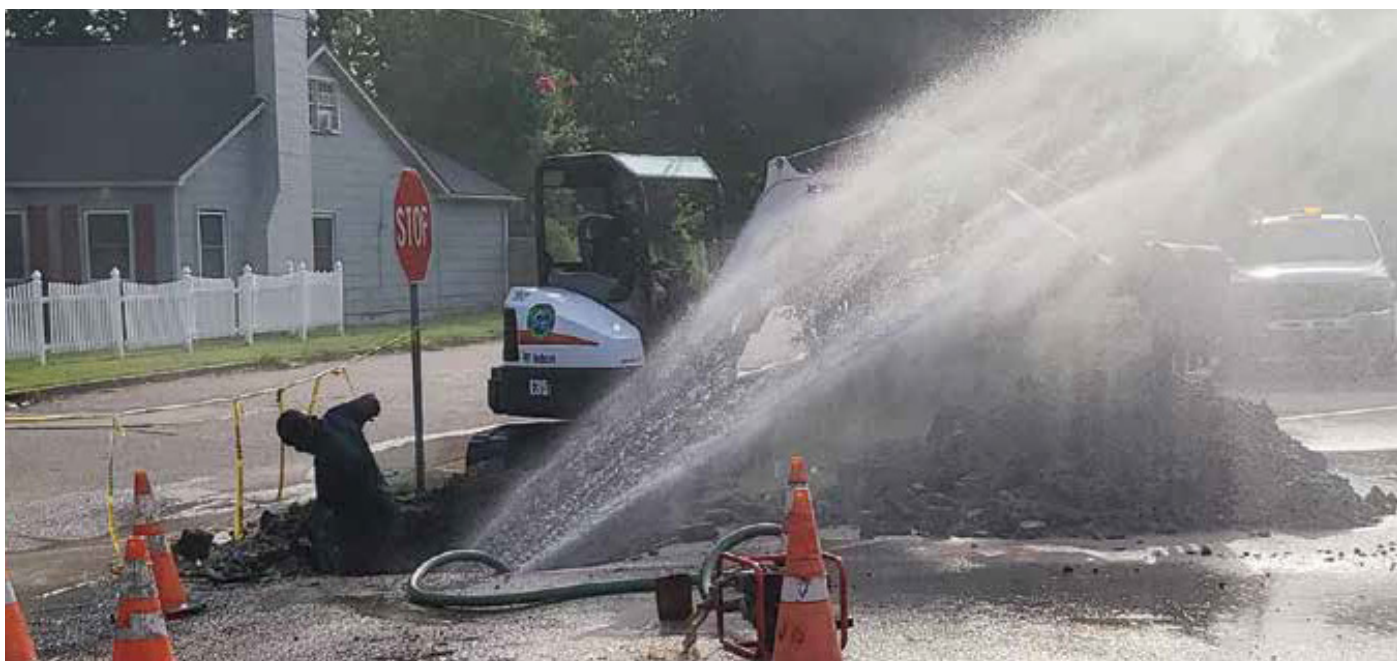
Greenville alerted to leak on 16-inch water main through ASTERRA Recover program. Photo courtesy of David Hangar, Water Maintenance Division, City of Greenville.

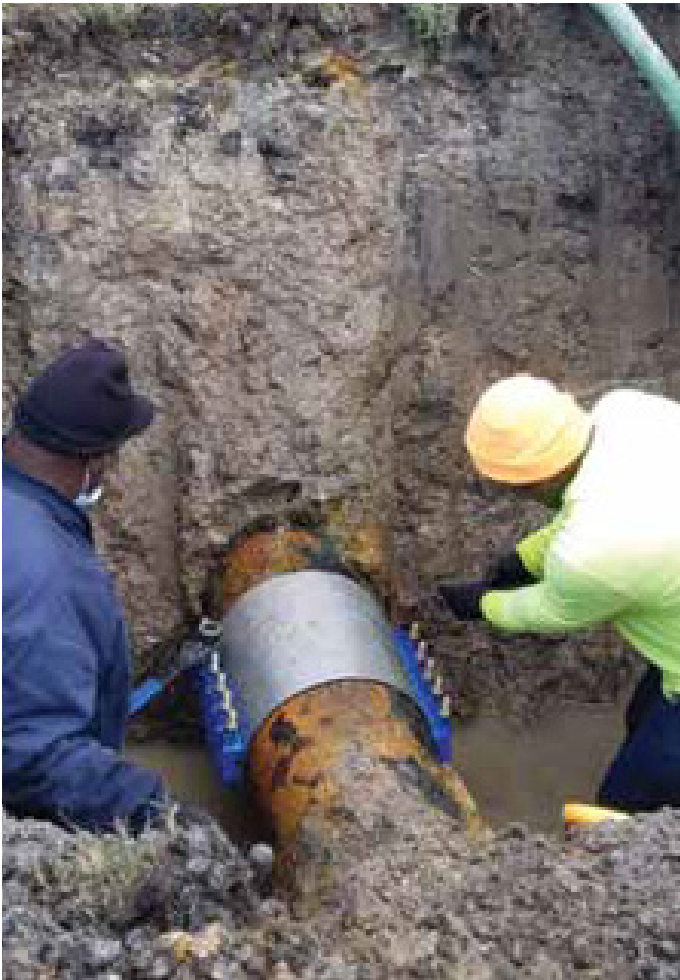
Greenville crew repairs leak that would likely have gone undetected.
Photo courtesy of David Hangar, Water Maintenance Division, City of Greenville.
