Drought Resiliency: Securing Drinking Water Supply in Northern Italy with Satellite Leak Detection

Originally published by Alfa SRL, adapted by ASTERRA

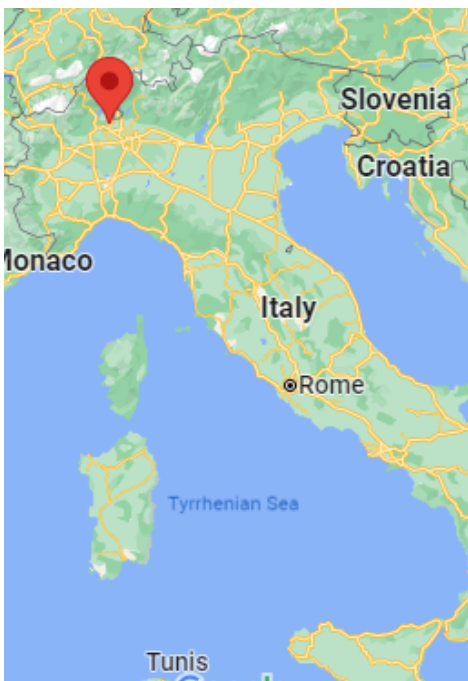
Figure 1. (left) Territory of the Province of Varese covered in the first service of the project of leak detection via satellite analysis in collaboration with 2f Water Venture, ASTERRA, and Alfa S.r.l.

The collaboration between Alfa S.r.l., 2f Water Venture, and ASTERRA began in 2022 with a first satellite analysis carried out on most of the territory of Alfa S.r.l., that covered 4.119,9 km of

pipes, corresponding to approximately 95.7% of the entire network (Figure 1). 433 leaks were detected from the satellite imaging analysis,

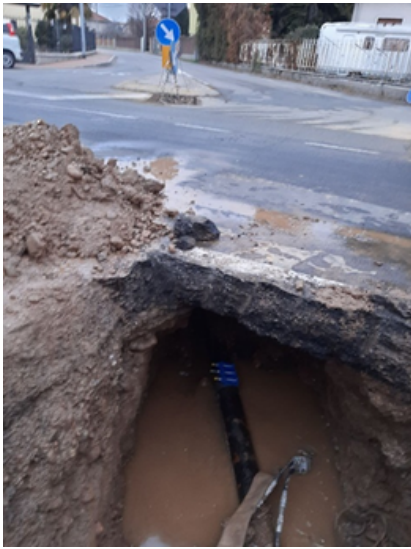
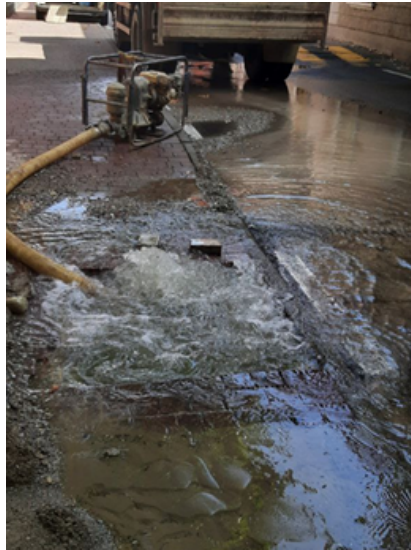
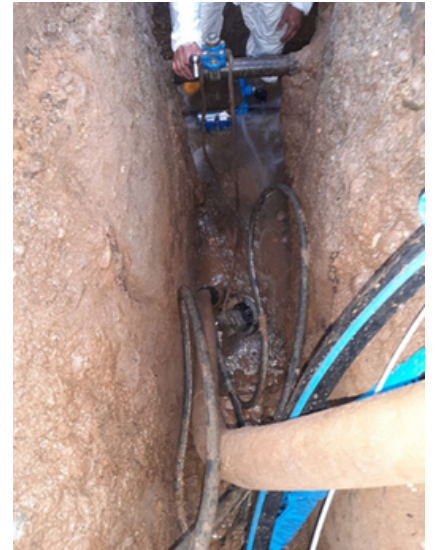
Figure 2 (above). Examples of quiet leaks in the water distribution network in the territory managed by Alfa S.r.l. detected via satellite analysis in collaboration with 2f Water Venture and ASTERRA.

Figure 2 shows three examples of quiet leaks detected in the water distribution network managed by Alfa S.r.l. using the satellite and raster analysis in collaboration with 2f Water Venture and ASTERRA. The amount of water loss in these leaks can be considerable, highlighting even more the utility of this collaboration in response to the drought conditions affecting the territory.
