# Detecting Leaks With Satellite Imagery

Satellite technology helps find water leaks throughout utility system

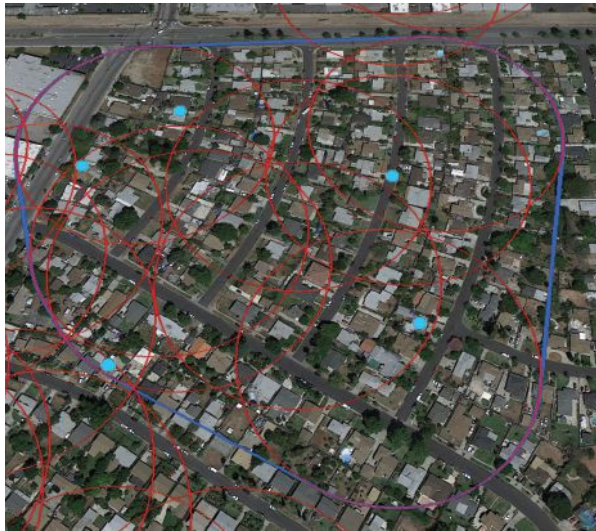
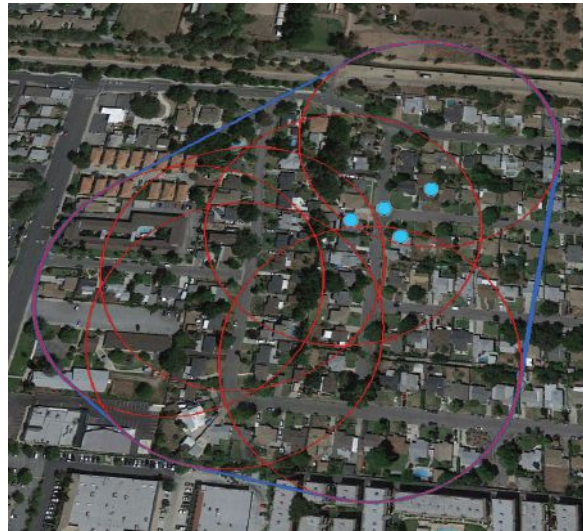
The blue circle in these images indicates the cluster zone for an area in which leaks may be found, and the red circles are buffer zones around points of interest for leaks.

Conversely, 439 POI's did overlap with at least one other POI during the 12-month project. The overlapping POI cluster can be related to work orders in a temporal manner to forecast when leaks will arise, where they will be located, and how long they will exist before surfacing and becoming visible. A 50-meter buffer zone around a POI was used to define a cluster. The large blue circle is the cluster zone while the red smaller circles are POI buffer zones, which make up the cluster. The blue dots are Utilis leaks, the yellow are work orders.
