THE FLOW

Using Satellite RADAR imaging to detect pipeline leaks in Hilton Head – A Case Study

By Paul Gagliardo, Senior Technical Fellow, Utilis

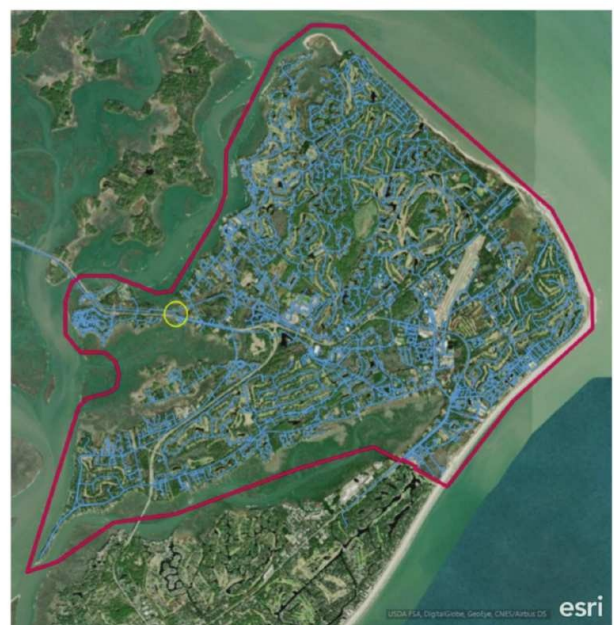
Figure 2.
The Hilton Head Public Service District (HHPSD) is outlined in red, with the pipe network shown in blue, and POI 88 circled in yellow.

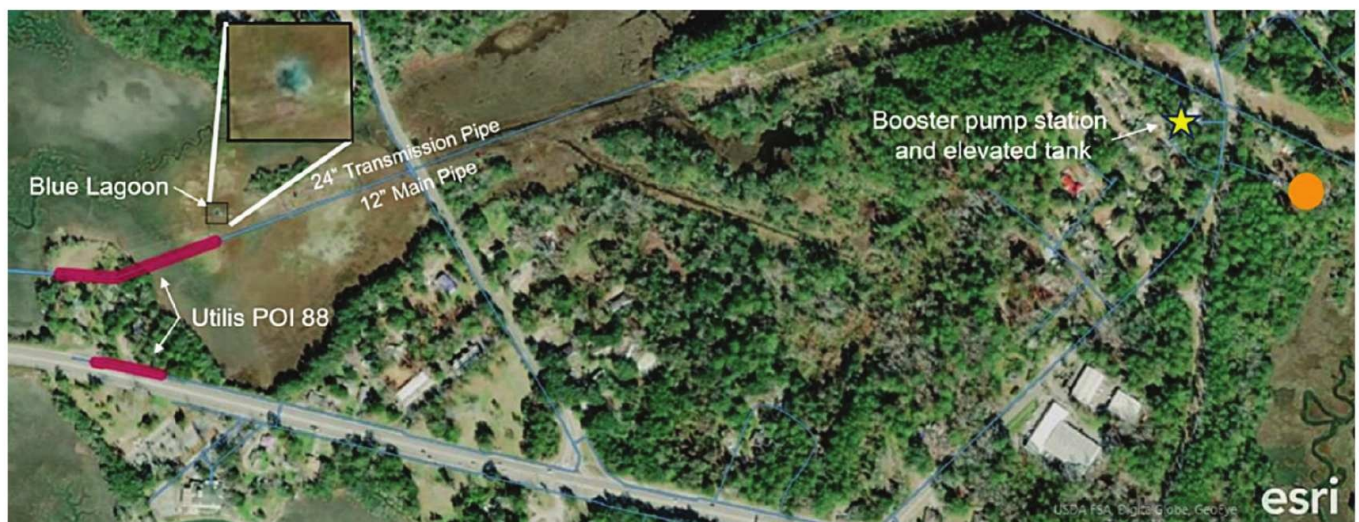
Figure 3

As you can see in **Figure 3**, Utilis POI 88 (highlighted red) and surrounding area, including the locations of the 'blue lagoon' (visible in the pop-out image as a small blue pond), the booster pump station/elevated tank (yellow star), the Upper Floridan Aquifer freshwater production well (orange circle), and the 12" distribution main and 24" inch transmission pipeline (teal line).

The POI was inspected during a low tide period. There are no listening points available due to the nature of the main, a regional transmission pipe, so the crew relied on a visual inspection. The site was visited and there were noticeable animal footprints in the tidal marsh leading to a specific location. Upon inspection of that location a 'blue lagoon' was discovered. This blue lagoon was the surfacing of a potable water leak from the twelve-inch main. The main had a hole near one of the concrete collars as big as a softball. Because the leak was proximate to the source of pressure there was no indication of a problem. A clamp was installed to temporarily fix the leak, while a permanent leak fix could be planned and executed.

The discovery of the leak also uncovered geolocation errors in the department's pipe map layer.
