THE JOURNAL FOR WATER RESOURCE MANAGEMENT

PROOF THROUGH PILOT TESTING

A side-by-side comparison of leak detection technologies

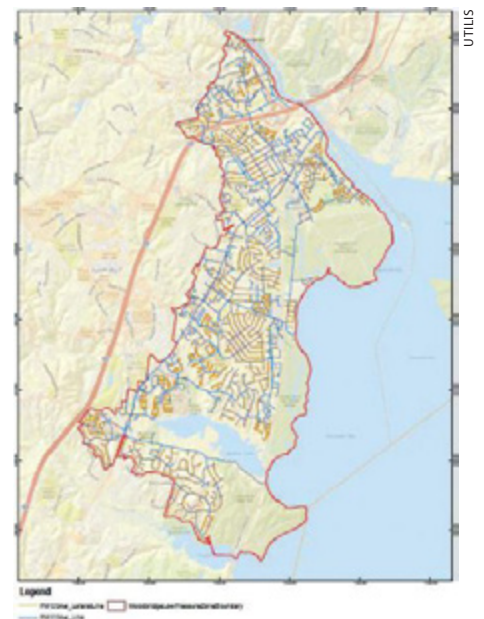
Figure 1. The area of interest evaluated in the pilot test is approximately 200 miles of water main and service pipe.

The PWCSA focused the pilot study, technology validation program, and AOI on the Woodbridge low pressure zone. This area includes approximately 200 miles of water main and service pipe as shown in Figure 1. This location was chosen due to its elevated age of pipe and because it has an estimated real water loss of 15%, which is above other sections of the PWCSA system.

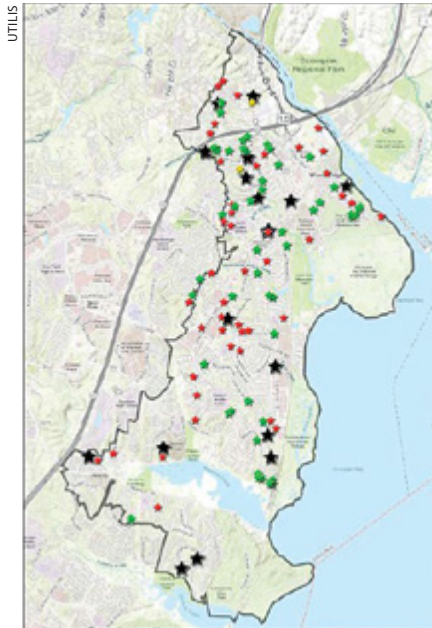
Figure 2 shows the spatial distribution of leaks found in the AOI during the study period. The black stars are the leaks found pursuant to the traditional methodology. The green stars are the leaks found using the Utilis satellite-directed methodology. The red stars are satellite-identified POI where no leaks were found when inspected. Because both crews were evaluating the same area during the same timeframe, there were some instances where the satellite-identified findings had already been repaired by the time the satellite field crews arrived on site. In Figure 2, where a red star and black star are in the same general location, the leak was identified and repaired prior to Hydromax's fieldwork in this area.

Figure 2. The spatial distribution of leaks found during the study period

As can also be observed in Figure 2, there are clusters of leaks and Utilis-generated POI. This reinforces the Utilis value proposition because it validates the concept of non-randomness of leaks in a system. This data artifact has been seen in other study areas, where leaks are clustered around a number of satellite identified POI. This data can also be used in an asset management manner, whereby the clusters can be seen as potential areas to replace entire sections of pipe. The POI map can be used as a GIS data overlay to be used in conjunction with other information for utility managers to make capital repair and replace decisions.
