Determination of Soil Moisture from Space

and its Application in the Assessment of Linear Geotechnical Infrastructure

Jonathan Lynch, Lead Ground Engineer at ASTERRA

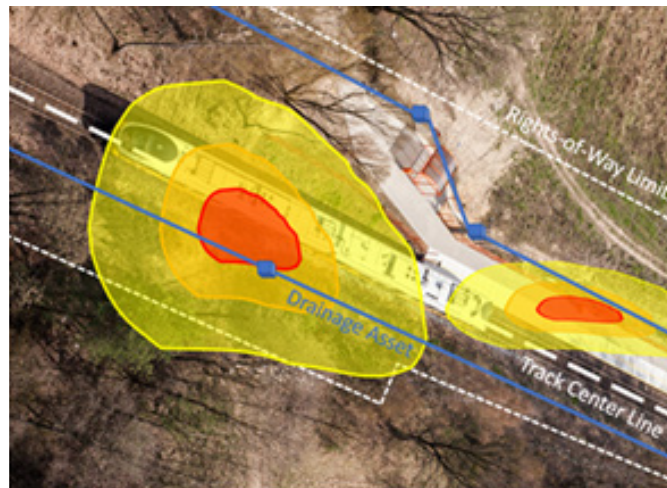
Figure 2. Example EarthWorks soil moisture map

The EarthWorks product provides a soil moisture map (Figure 2) for the user with specific information containing shallow soil moisture content within any area of interest specified by the user, be it linear infrastructure or large site development areas without setting foot on the ground. Contoured soil moisture heat maps are created enabling the asset owner and engineers to assess and target their inspections of known problem areas and importantly unknown problem areas for both earthwork assets and drainage. The user can either view the information within a GSI Cloud provided by EarthWorks or choose to export the data to any GIS system to perform further geospatial analysis .

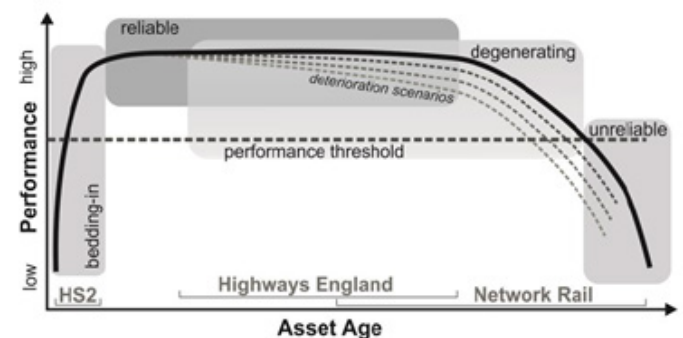
Figure 3. Deterioration curve for transport earthworks

Figure 3 shows a deterioration curve (Glendinning et al, 2015) and indicates that EarthWork assets for Network Rail lie to the right of the deterioration model (degenerating/unreliable) expressing the general stability situation of old geotechnical assets, whilst the Highways England assets are more within the central ‘reliable/degenerating’ area. Newer infrastructure is still within the bedding in period, eg HS2, and HS1 (although not shown).
